An Ordinary RFP Leads to an Unexpected Proposal & Staggering Savings

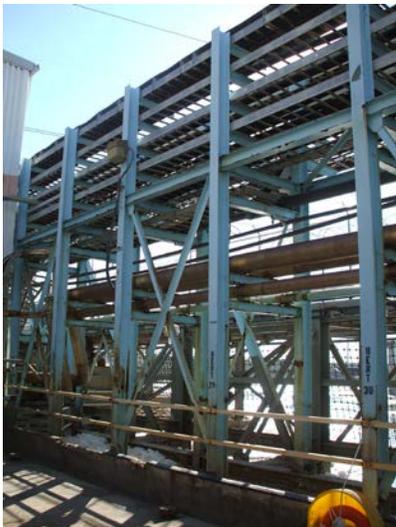
BEFORE

After years of corrosion from sea salt, a Florida-based industrial plant issued an RFP to have its degraded carbon steel pipe and cable tray support structure sandblasted and recoated. The structure ran approximately 400 feet, with several changes in elevation and direction, and incorporated many different sizes of pipe, conduit and stainless steel electrical cable trays. It was extremely corroded having suffered from delamination.

Our engineers clearly understood the problem, and they had an innovative solution in mind. Rather than sandblast, repair and recoat the existing structure, Engineered Rigging submitted a proposal to replace it with laser-welded 316L stainless steel. Every detail in our proposal emphasized corrosion prevention (even the fasteners were a high-strength stainless steel), while maintaining the strength of the original structure.

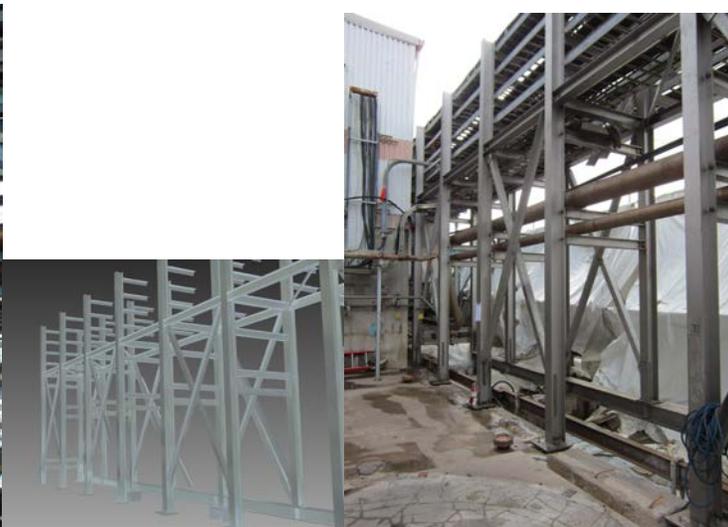
AFTER

- All engineering, labor and equipment to replace the pipe and cable tray support structure: Laser scanned the existing structure; created fabrication drawings for all beams, columns and braces; fabricated all 316L members; replaced all existing degraded carbon steel with 316L stainless sections utilizing temporary shoring supports; replaced all existing base plates and anchor bolts; completed all associated core drilling; and replaced all pipe with 316L stainless steel pipes on multiple lines.
- The design, installation and utilization of a cart-mounted articulating boom crane on the adjacent security catwalk for rigging operations associated with the support structure replacement.
