# CASE STUDY

An Ordinary RFP Leads to an Unexpected  
Proposal & Staggering Savings

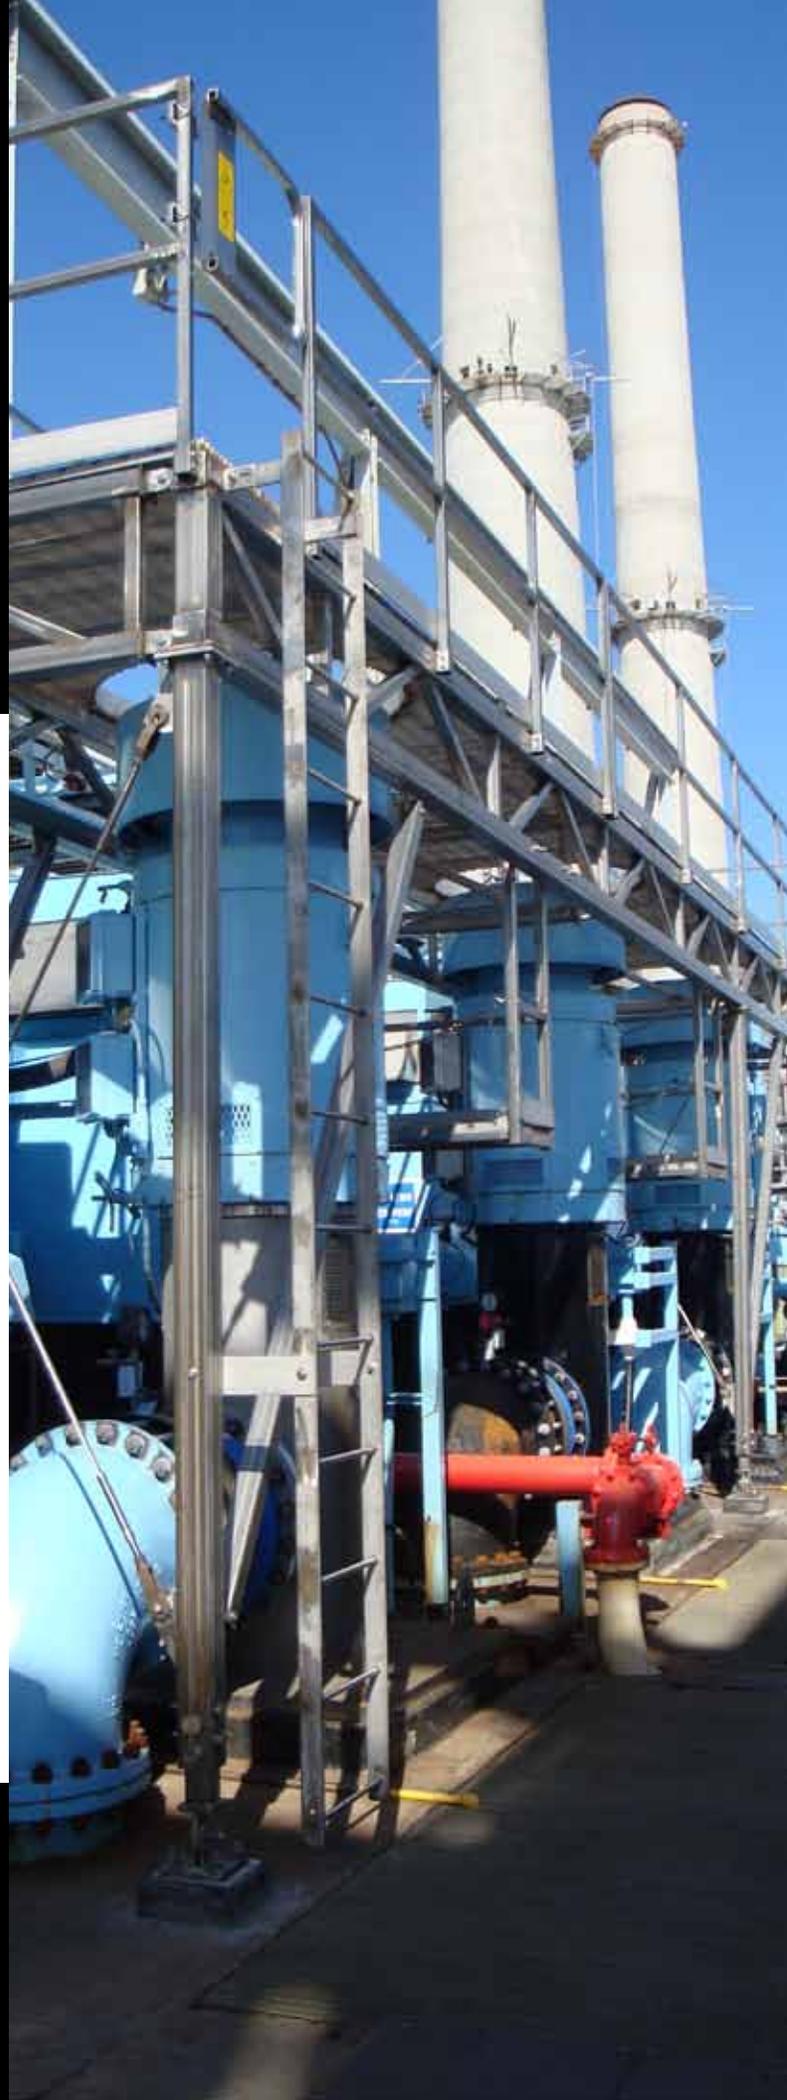
After years of corrosion from sea salt, a Florida-based industrial plant issued an RFP to have its degraded carbon steel pipe and cable tray support structure sandblasted and recoated. The structure ran approximately 400 feet, with several changes in elevation and direction, and incorporated many different sizes of pipe, conduit and stainless steel electrical cable trays. It was extremely corroded having suffered from delamination.

Our engineers clearly understood the problem, and they had an innovative solution in mind. Rather than sandblast, repair and recoat the existing structure, Engineered Rigging submitted a proposal to replace it with laser-welded 316L stainless steel. Every detail in our proposal emphasized corrosion prevention (even the fasteners were a high-strength stainless steel), while maintaining the strength of the original structure.

**Engineering Expertise:** Rather than sandblast and repair the catwalk and cable tray support structure, ER's engineers proposed replacing it with corrosion-resistant 316L stainless steel. ER also developed a 3D "as-built" model that included all changes that the plant wanted to make to the existing structure.

**Custom Fabrication:** ER laser scanned the existing structure; created fabrication drawings for all beams, columns and braces; and fabricated all 316L members at its facility.

**Skilled Craft:** ER's crews provided a turnkey solution, which included sandblasting, weld repairs, core drilling, the replacement of all pipe with 316L stainless steel pipes and the installation of new grating.
